# **Optimized Strategy for Scaling Up Deep Energy Retrofit**

Final Report

**The New York State  
Energy Research and Development Authority**  
Albany, NY

**Taitem Engineering, PC**  
Ithaca, NY  
Beth Mielbrecht

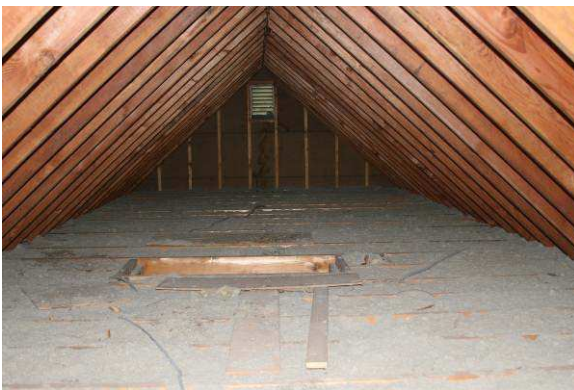
Figure 8: Hawthorne - Attic prior to start of work

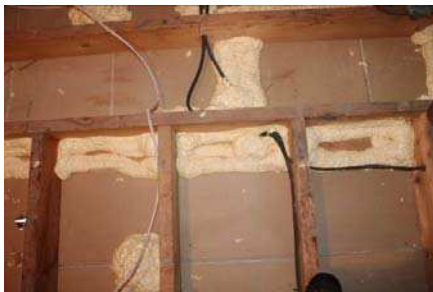
Figure 10: West Hill - Spray foam used to seal top plates and electrical penetrations

Interior and exterior top plates were sealed with a coat of 2-part polyurethane foam. This sealed sheetrock/top plate junctions and wiring penetrations. On the exterior bearing walls, the top plates were sealed to the exterior foam sheathing, which extended between the rafter tails up to the vent chutes to form a wind block.

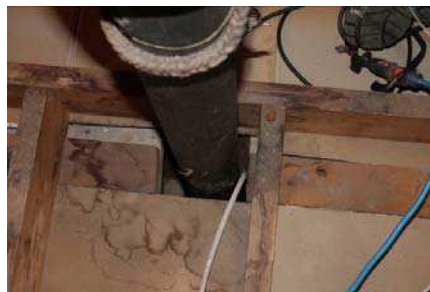
Figure 11: West Hill - Plumbing vent with air leaks

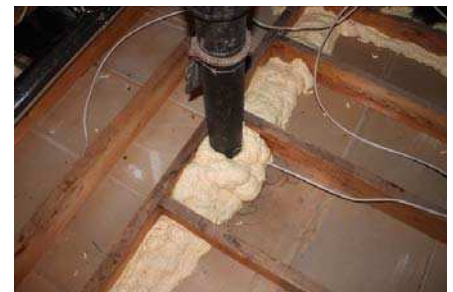
Figure 12: West Hill - The plumbing vent is now sealed

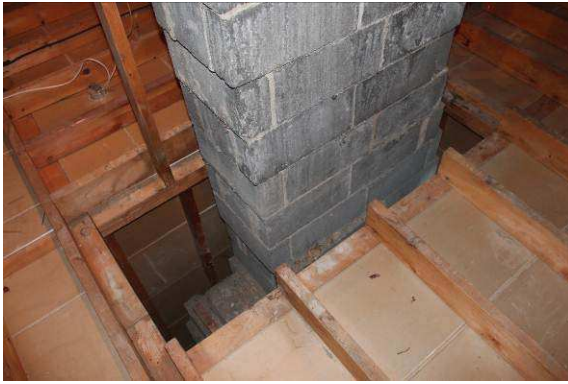
Figure 13: West Hill - A giant air leak around the chimney

At West Hill, a very large chase around the CMU chimney, which housed both the fireplace flue and the old boiler flue was airsealed. This chase, while originally covered with faced fiberglass, connected directly to grilles in the first floor wall on either side of the fireplace. Additional framing was installed to support a Thermax air barrier at ceiling level, which was sealed with two-part foam. Sheet metal and high-temperature caulk were used within 2" of the chimney itself.

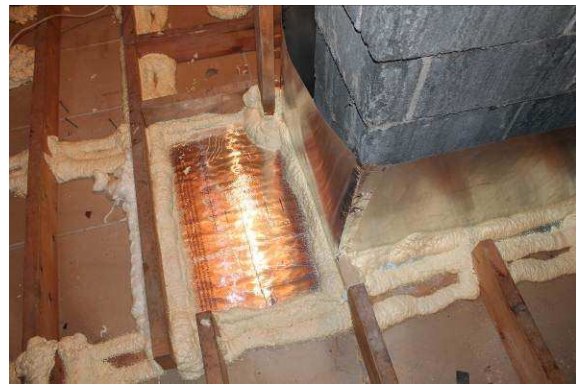
Figure 14: West Hill - Chimney air sealed; a metal dam provides 2" clearance between cellulose and chimney

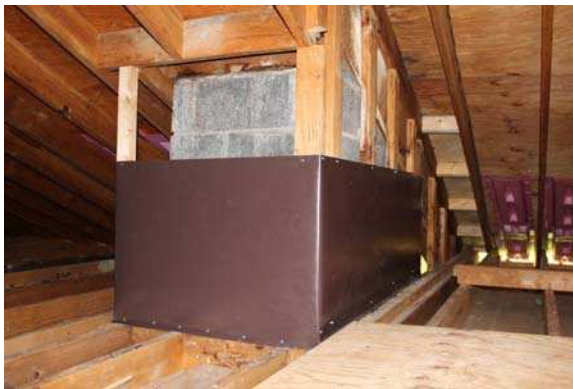
At Ellis Hollow, removal of the old attic floor decking and fiberglass batts revealed significant air leakage pathways. The two largest breaks in the attic plane were above the stairs to the basement and above the main floor fireplace. Additional framing was installed to allow attachment of foam board over the stairs, in line with the rest of the attic plane. The areas adjoining the chimney were sealed with foil-faced ductboard and high-temperature caulk.

Figure 15: Ellis Hollow - The chimney chase was sealed with foil-faced ductboard and high temperature caulk

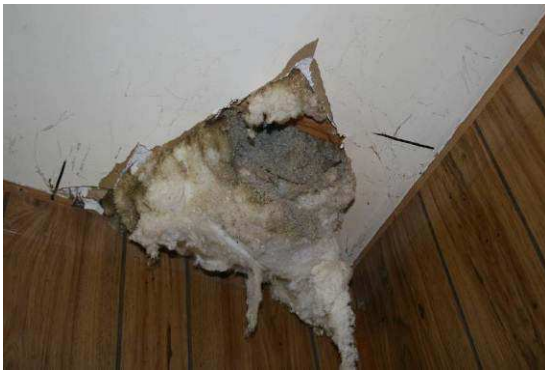
Figure 16: Hawthorne - Holes were patched and repaired

At Hawthorne, a CMU chimney was present at the beginning of the project, extending from the basement to above the roof line. This was demolished down to the basement, and the holes in the ceiling plane were patched with sheetrock. Also at Hawthorne, general repairs to holes in sheetrock were performed by the general contractor. An older recessed light was removed, the sheetrock patched, and a surface-mounted fixture installed.

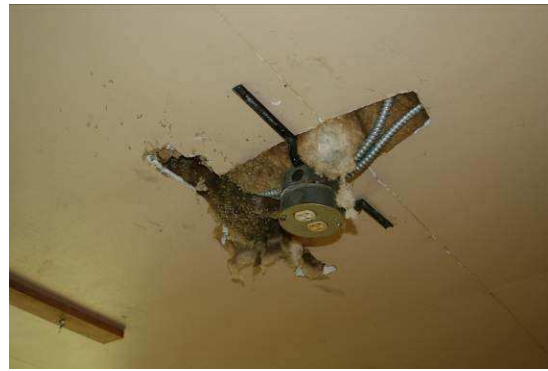
Figure 17: Hawthorne - The ceiling plane contained some obvious air sealing opportunities

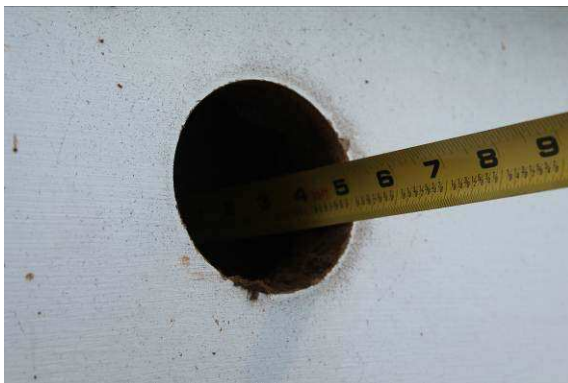
At West Hill, with the exception of the garage wall, which contained some perlite and fiberglass, and the wall behind the kitchen sink, which contained a few pieces of fiberglass, the main floor wall cavities were empty. A large bypass was discovered behind a bath tub on an exterior wall. After blocking the bypass with fiberglass to prevent blow-by into the interior of the house, the cavity was packed with high-density cellulose insulation.

Figure 18: West Hill - The 2 x 4 wall cavities on exterior walls were completely empty

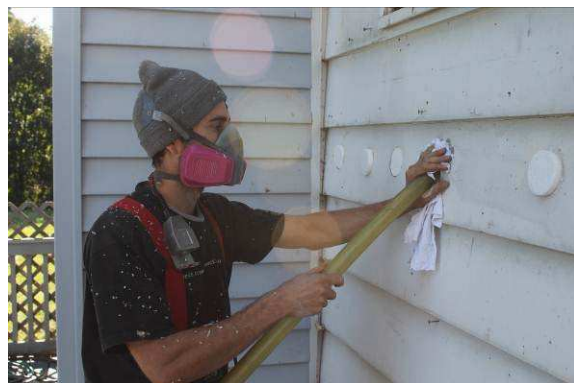
Figure 19: West Hill - Dense-packing the wall cavities

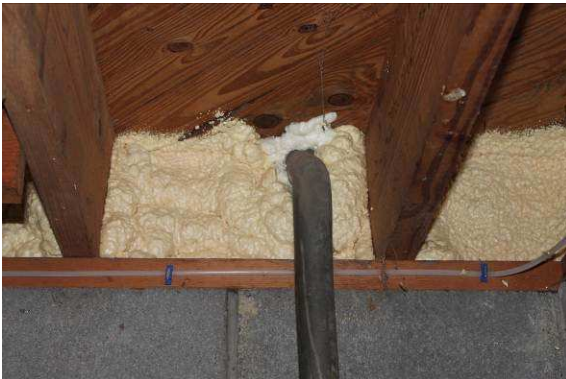
Figure 20: West Hill - Spray foam in basement rim joist. In this photo, Thermax has not yet been installed on the walls, and the sill plate has not yet been sealed to the block foundation

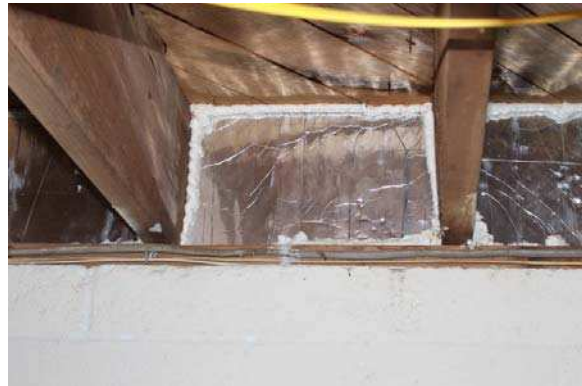
At Cayuga Heights, the band joist and sill areas in the main basement were sealed with Thermax blocks and polyurethane foam. The ceiling of a small crawlspace over a bathroom addition was sealed and insulated with Thermax; short pony walls in a sun room addition were sealed with closed-cell foam.

Figure 21: Cayuga Heights - Basement rim joist with spray foam and Thermax

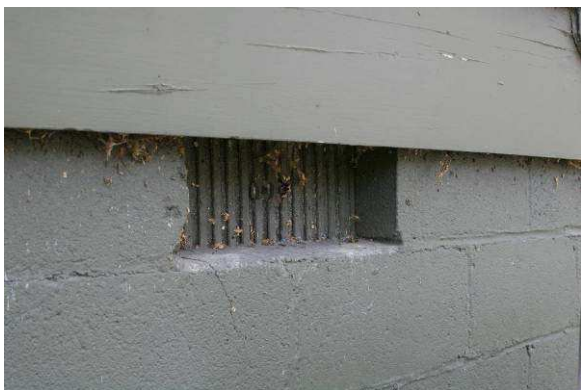
At Hawthorne, the extremely leaky crawlspace access panel was temporarily replaced by a piece of 2.5" Thermax and was replaced by a tight-fitting, weatherstripped wood access panel. Each of the two crawlspaces contained metal crawlspace vents. These were replaced by CMU blocks, mortared in place.

Figure 22: Hawthorne - Metal crawlspace vents were replaced with CMU blocks

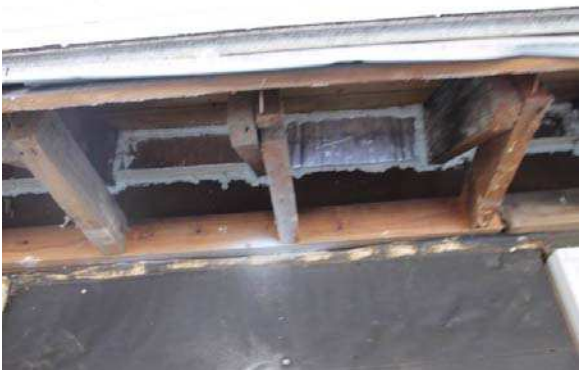
One aspect of the Cayuga Heights' construction created an unusual and significant air leakage pathway. The house was originally a one-story ranch; a partial second story was added in the 1980s. The original one-story roof line persists as a vented overhang, which allowed air to intrude between the first and second floors. This area was carefully sealed in line with the exterior walls using Thermax blocks and polyurethane foam.

Figure 23: Cayuga Heights - Air sealing at vented overhang

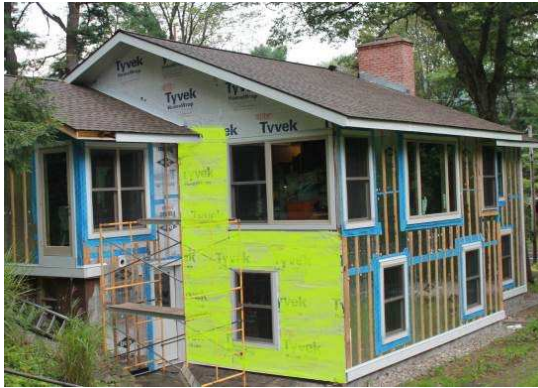
foam sheathing was insulated with closed cell foam rather than cellulose. This allowed a cavity R value of R-21 for this small section of the house.

Figure 27: Ellis Hollow - Due to narrow clearances to a door, the shaded wall area below was not insulated with exterior sheathing. Closed-cell spray foam was installed to provide maximum R value in the wall cavities
