# Energiesprong: A Dutch Approach to Deep Energy Retrofits and Its Applicability to the New York Market

Final Report | Report 18-10 | March 2018

**Taitem Engineering, P.C.**

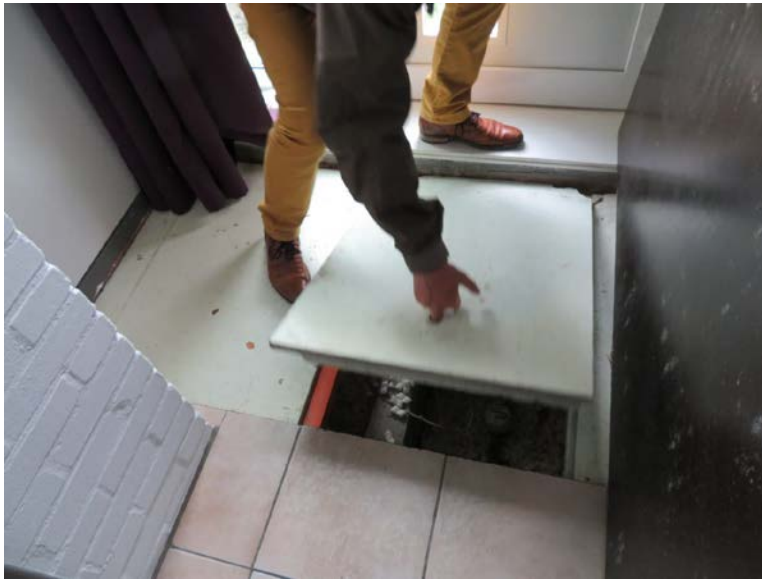
**Figure 1. Floor panel access to crawlspace**

For plumbing, the water service enters from a crawlspace below the front entrance hall, accessible with an access panel, hidden below a mat, as seen in Figure 1. As buildings go all-electric, water meters are being relocated into a closet in the entry, where gas meters have been removed. The entry closet also contains the existing electric meter and breaker panels.

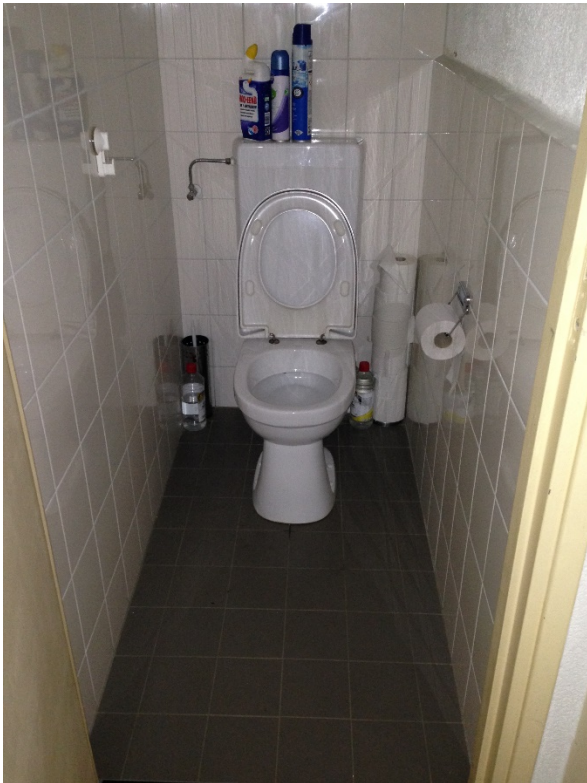
**Figure 2. Downstairs bathroom**

A single toilet serves each house, located in the downstairs hall, typically without a sink, as seen in Figure 2. An upstairs bathroom provides a shower (usually no bath), but no toilet. Clothes washers may be located in the upstairs bathroom or downstairs in the kitchen.

Only the toilet is in the downstairs bathroom, there is no sink.

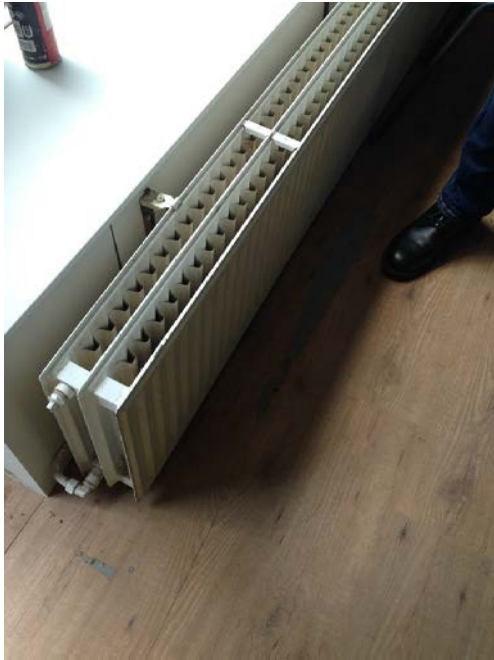
**Figure 3. Radiator left inside the building**

The gas-fired existing heating systems are replaced with air-to-water heat pumps, which also supply domestic hot water. Interestingly, existing radiators are typically kept as part of the new air-to-water heat pump system, shown in Figure 3. The insulation and air-sealing measures reduce the building's heat loss sufficiently such that existing radiators can deliver the required heat using the smaller water temperature rise generated by the heat pump instead of the comparatively greater water temperature increase delivered by the pre-retrofit boiler systems.

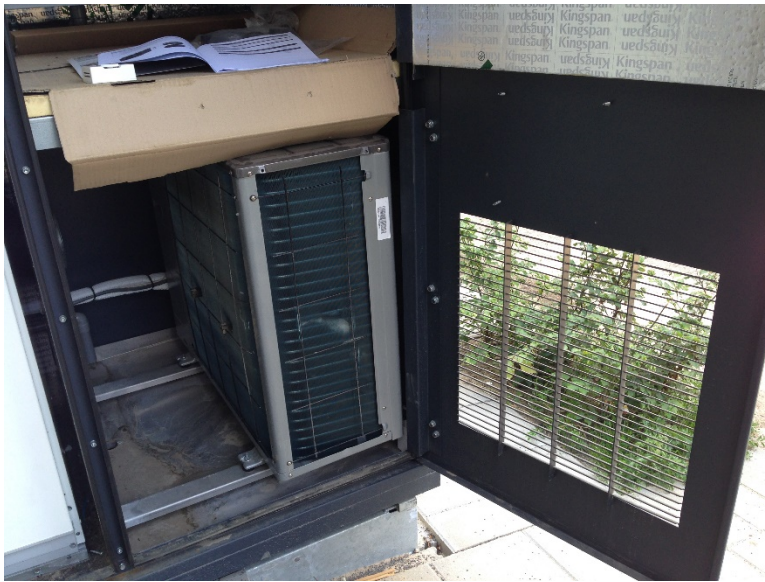
**Figure 5. The outdoor fan and heat exchanger**

An exterior mechanical room is installed to simplify installation and service of equipment. This includes the heat pump, heat recovery ventilator, water heater, and solar inverter/controls. The heat pump components in this shed include the air-to-water heat exchanger and pump that delivers water to the heated house as well as the outdoor fan and heat exchanger, shown in Figure 5. Exterior access means contractors can service equipment without disturbing residents, which is viewed as a plus for both residents and contractors.

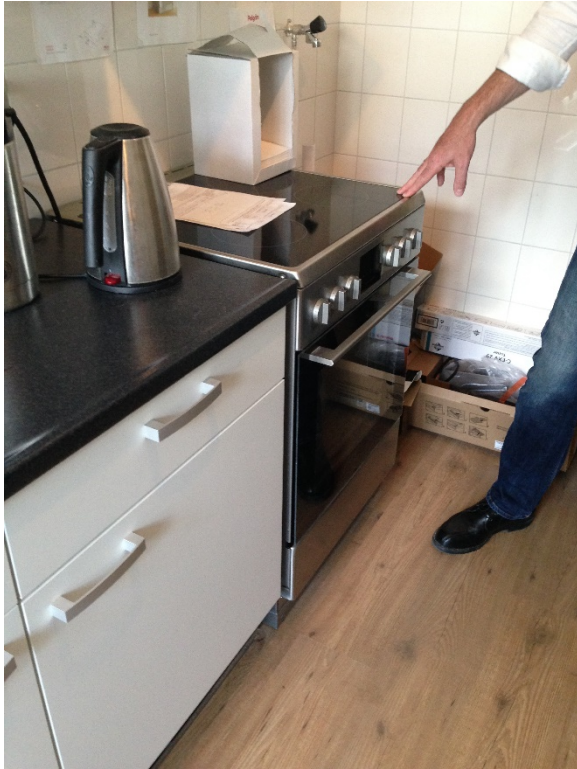
**Figure 6. Induction stove**

Lights and appliances are generally not replaced; however, in some cases incentives were provided for residents to do so. The one exception is gas-fired cookstoves; these must be replaced because gas is entirely disconnected from the buildings. They are replaced as part of the projects with high-efficiency induction electric cookstoves, shown in Figure 6. Because induction stoves can only use magnetic cookware, such as cast iron or magnetic stainless steel, new cookware is provided to the residents, shown in Figure 7.

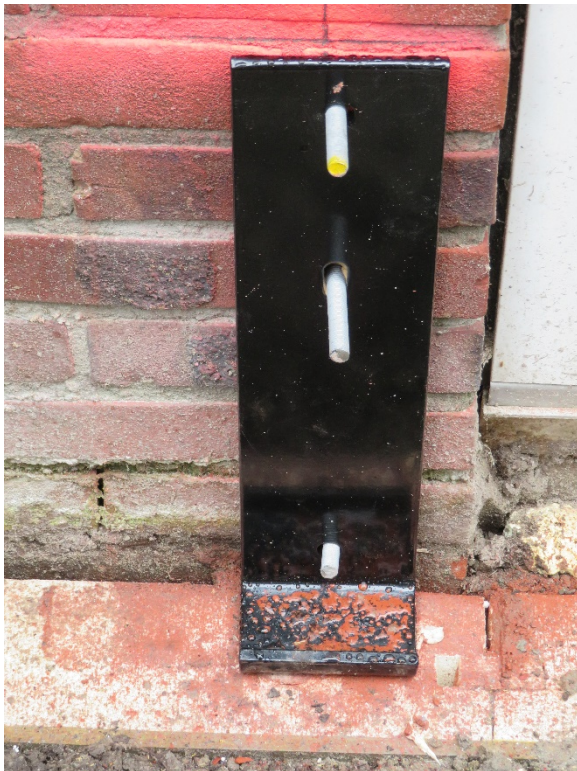
**Figure 8. Structural fasteners**

Construction begins with removing exterior wall elements, such as downspouts, house numbers, wall-mounted lighting, mailboxes, awnings, and more. The contractors then trench around each building to insulate the sub-surface foundation. Structural fasteners are mounted on existing walls (Figures 8 and 9), which will be used to support the new wall sections.

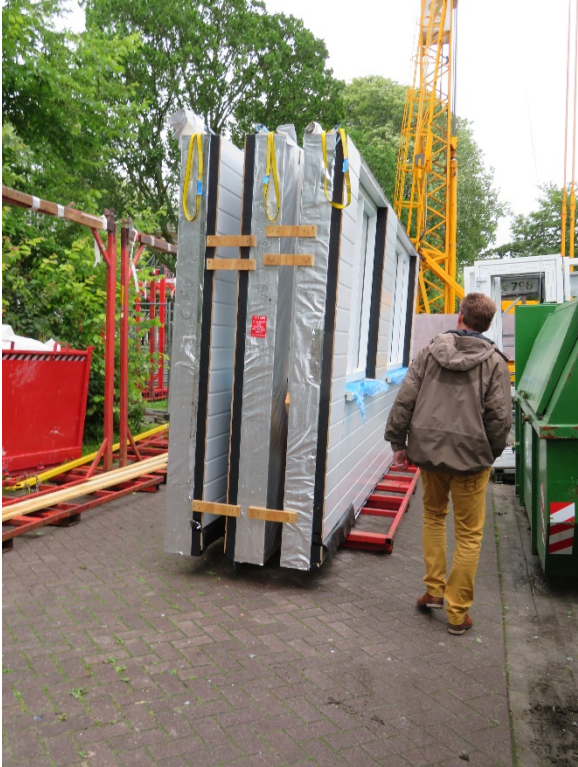
**Figure 10. New wall cladding sections are brought on-site by truck**

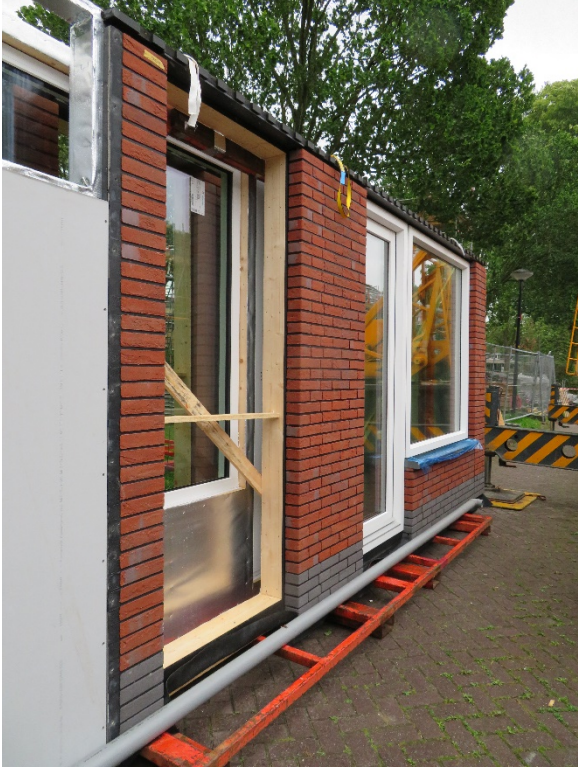
**Figure 11. New wall cladding sections being installed with full scaffolding**

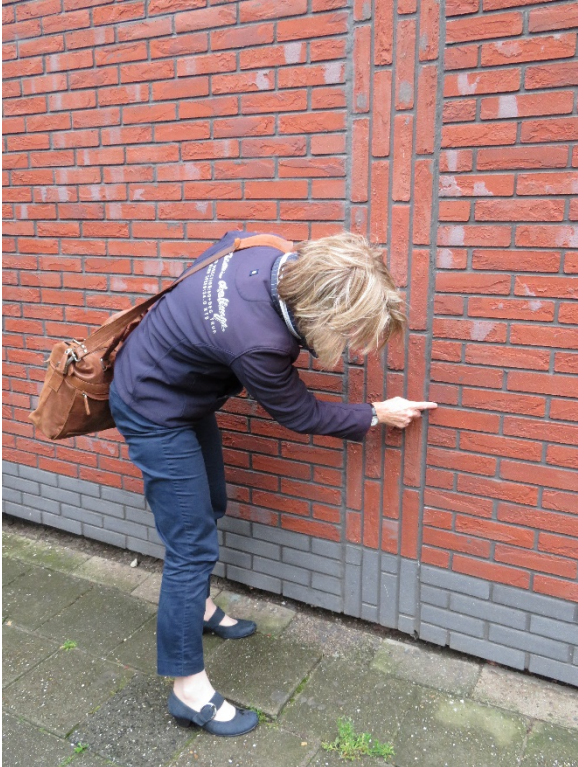
**Figure 12. Facing is typically a synthetic material**

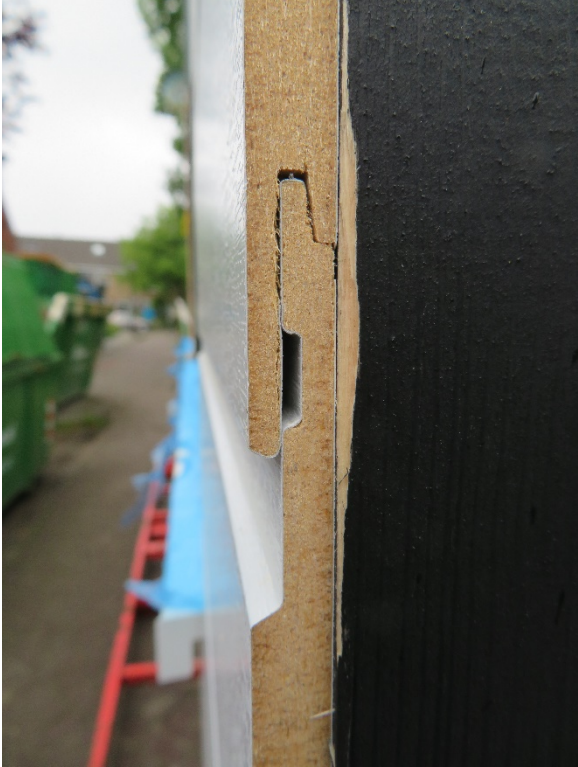
**Figure 14. Alternative siding includes particle-wood with a protective facing**

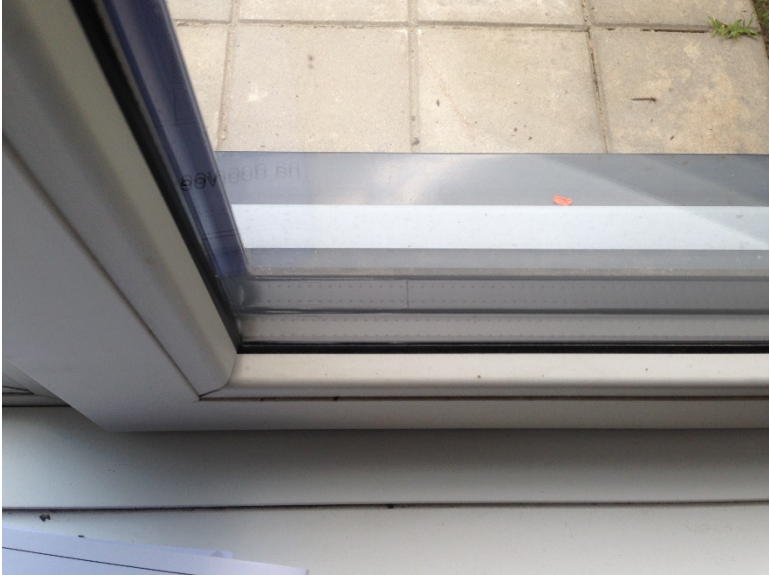
**Figure 16. High-performance windows**

The windows are extremely high-performance gasketed triple-glazed assemblies, as seen in Figure 16.

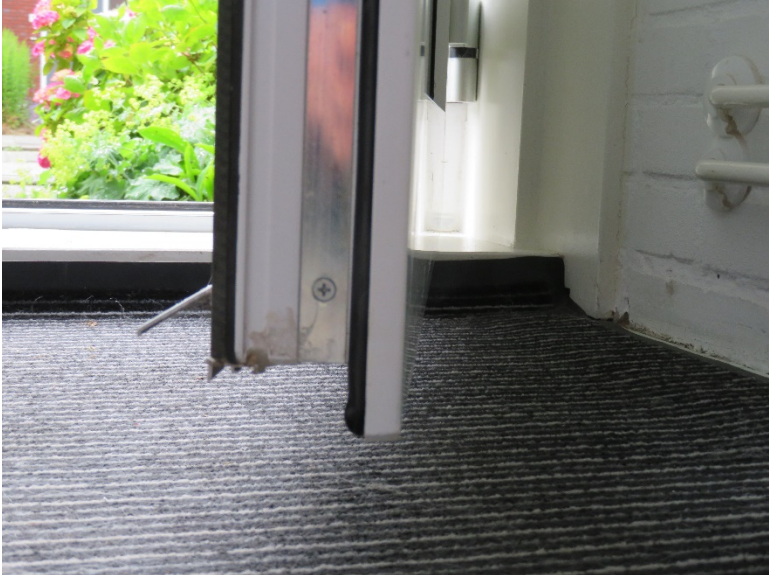
**Figure 17. The doors are high-performance gasketed and insulated doors**

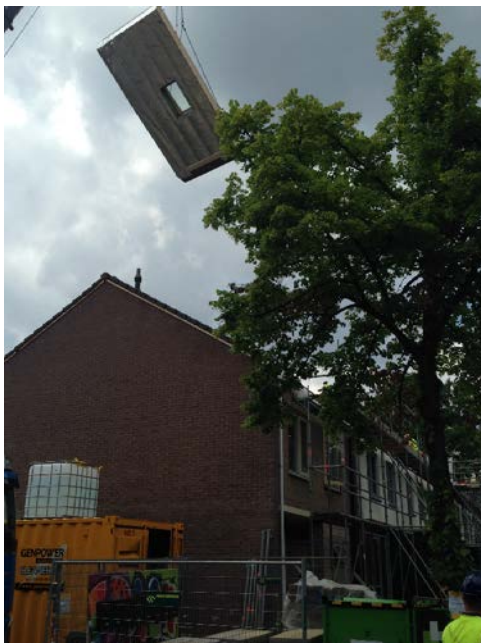
**Figure 19. Roof sections are lifted by a crane**

Exterior roof elements are removed, including chimneys and roof tiles. The roof sections, also brought on-site by truck, are lifted into place by crane, shown in Figure 19. The roof sections typically already have rails in place to receive the solar modules. The solar modules can then be lifted and placed on the roof.

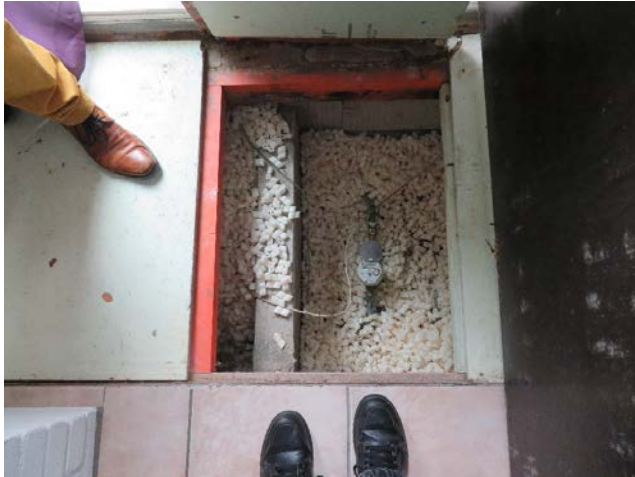
**Figure 20. Crawlspace insulated with polystyrene chips**

The work then moves indoors. Although most of the work is done outdoors, which is one of the promises of the program, there is still some important work that needs to happen indoors. For example, the gas meter is removed, as the buildings are essentially being fully electrified. Removing the gas meter results in substantial savings due to the elimination of the gas meter charge. The crawlspace is then insulated with loose expanded polystyrene chips (“flakes”), as seen in Figure 20.

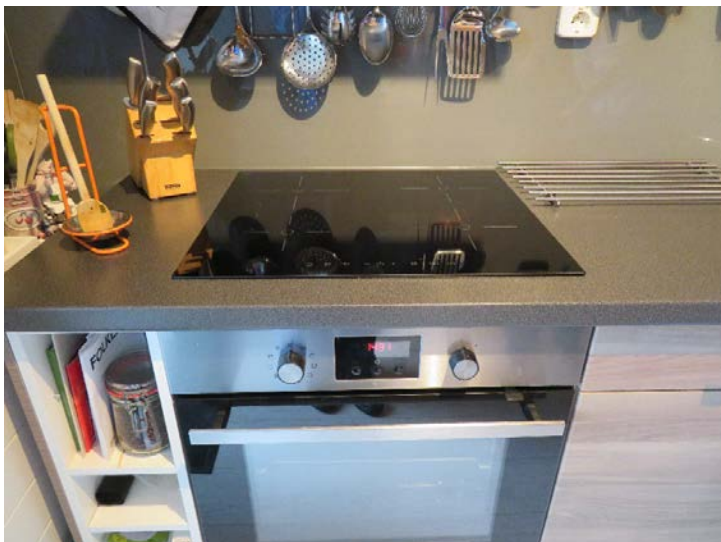
**Figure 23. Newly installed induction stove**

Gas stoves are replaced with induction electric stoves (Figure 23), and new cookware (pots, pans, etc.) that will work with them is provided.

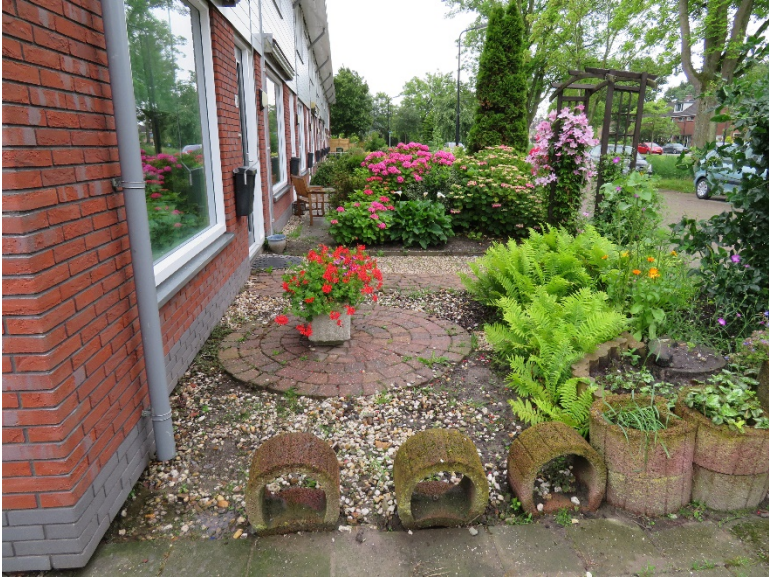
**Figure 24. Completed exterior work**

Finally, exterior work is completed, including restoration of the site and surface elements (gutters, downspouts, house numbers, mailboxes, etc.) reinstalled or replaced with new, shown in Figure 24.

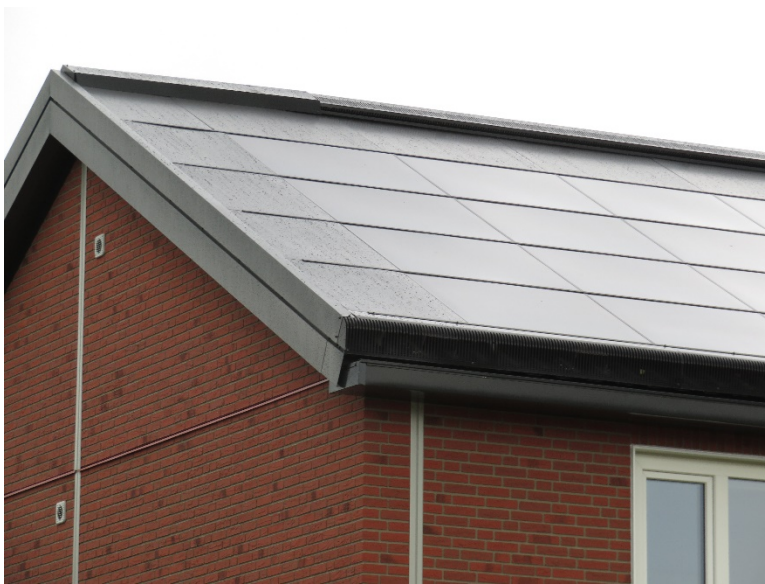
**Figure 27. Roof-mounted heat pump heat exchanger: air grilles are above gutters and at roof peak**

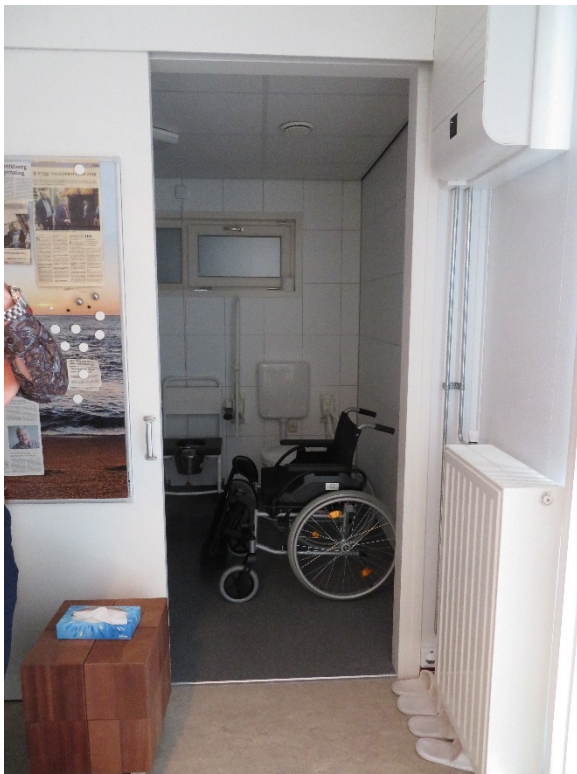
**Figure 30. Additional bathroom**

At one site, we saw that a first-floor addition had been added to the back of some of the homes. This is an “age-in-place” accommodation that provides an accessible bedroom and bathroom on the first floor (Figures 30 and 31).

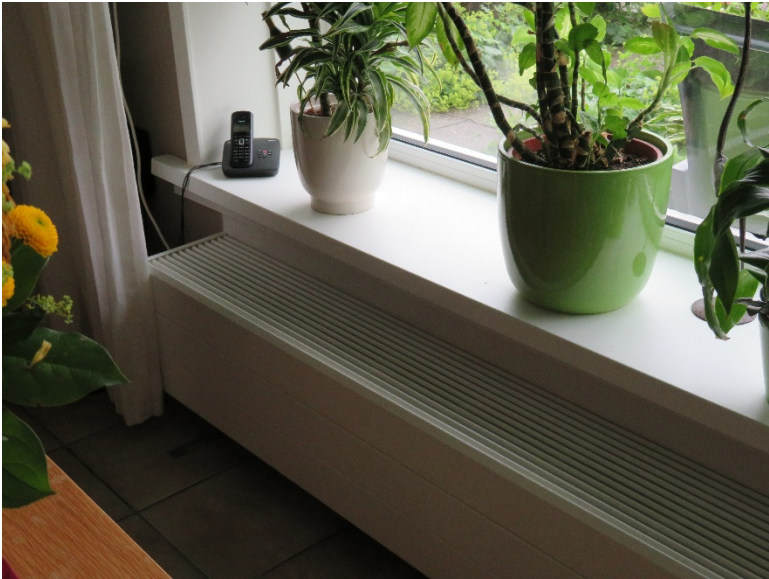
Figure A6. Radiator, below window extension used as a shelf

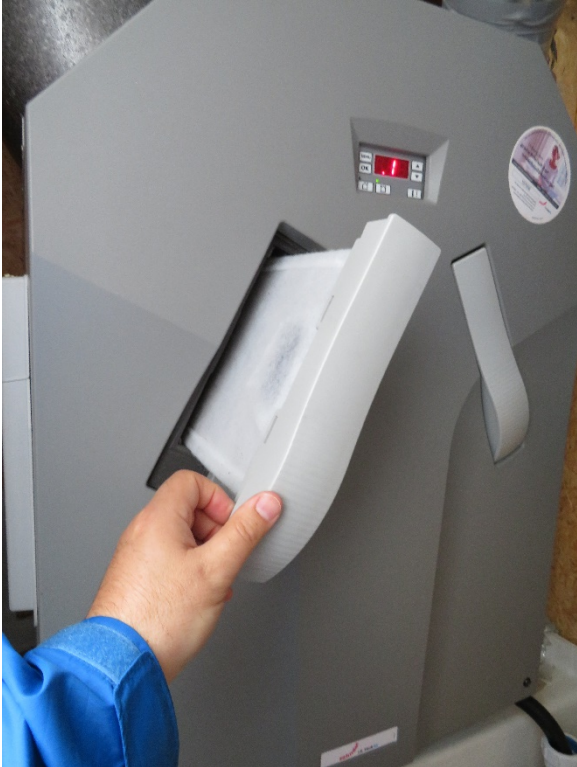
**Figure A8. Filter in heat recovery ventilator**

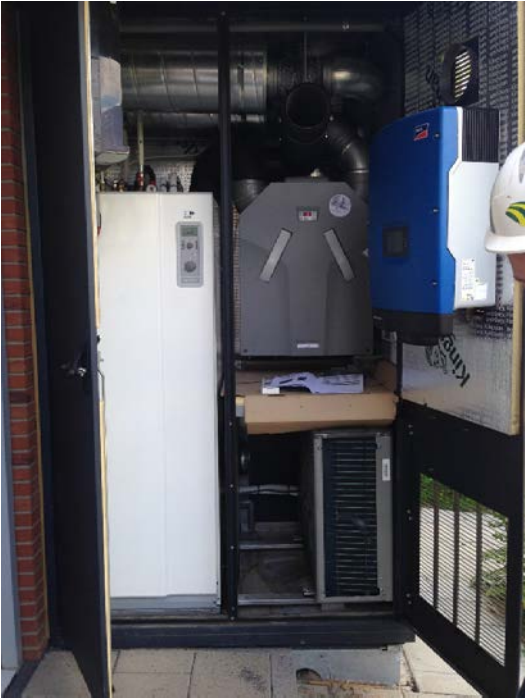
**Figure A12. Open mechanical room**

Lower right: Heat pump outdoor heat exchanger. Upper right fastened to interior of door: Solar inverter. Upper right inside the shed: Heat recovery ventilator. Top: Ventilation ductwork. Left (white): Water heater.

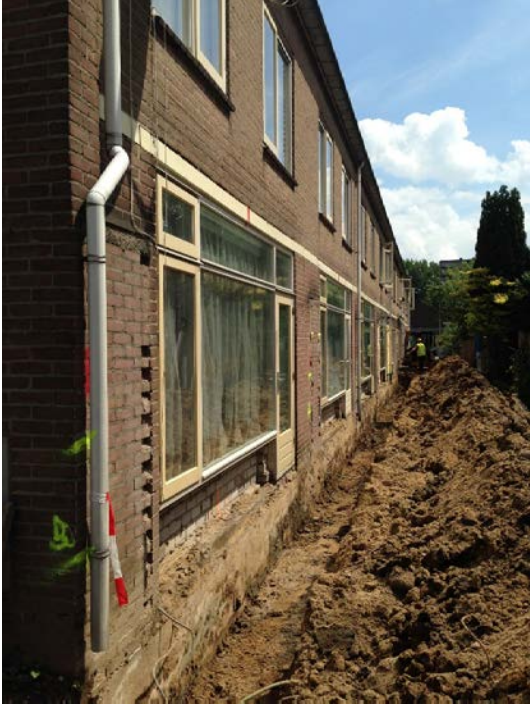
**Figure A13. Excavation to add foundation insulation**

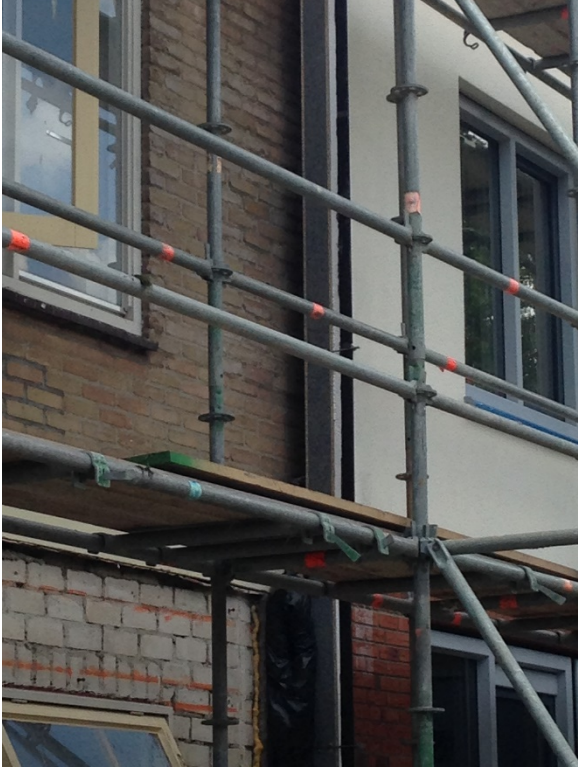
**Figure A16. New exterior wall assembly seen over the existing wall**

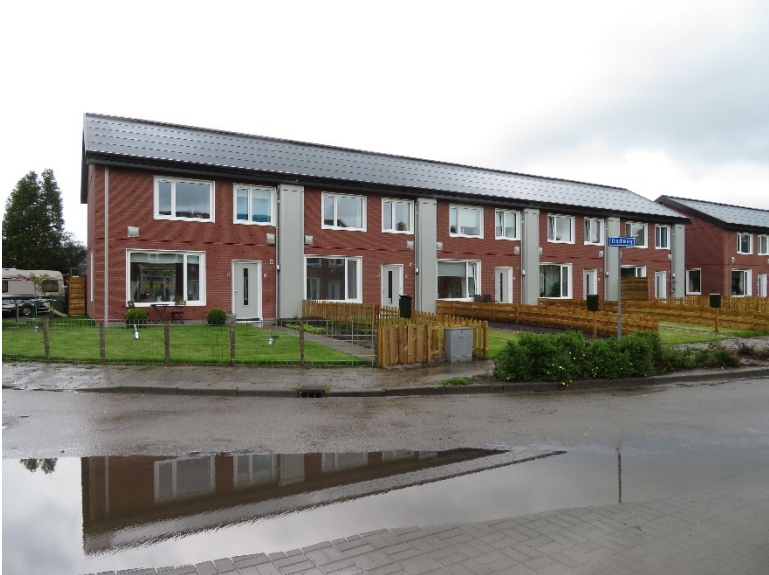
**Figure A20. Renovated building with shallow mechanical chase and individual exhaust fans**

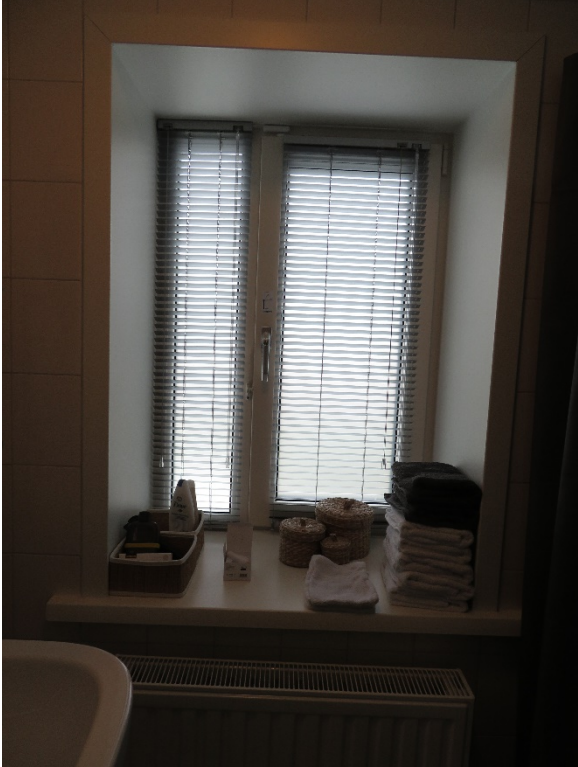
**Figure A33. New windows, with extension showing depth of wall.**

There was concern that the deeper wall dimension and associated window extensions might reduce natural light in the apartments. Residents were asked if they found this to be true, and it appeared there was no concern with loss of natural light. Residents also consistently reported liking the deeper shelf space created by the window extensions on the interior of the windows. This space is used for plants, other decorative displays, and as a general shelf. Appendix A shows examples of what the windows look like in the thicker walls.

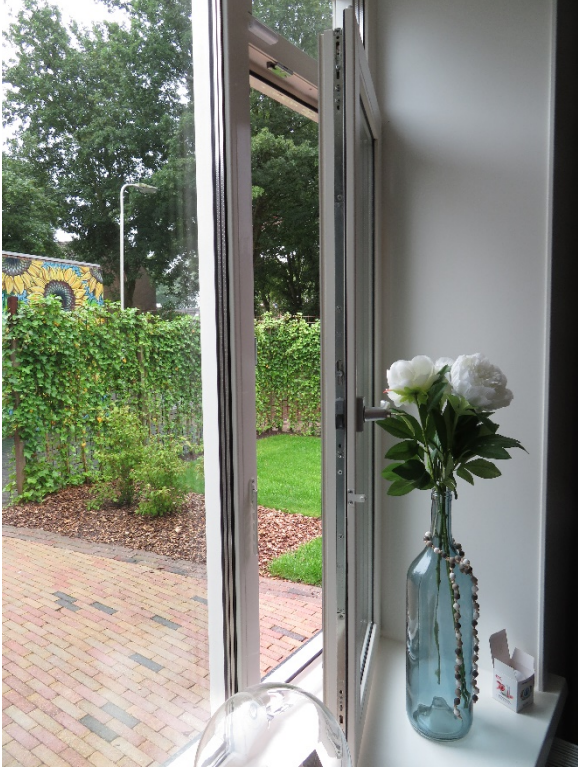
**Figure A34. New windows, with extension showing depth of wall**

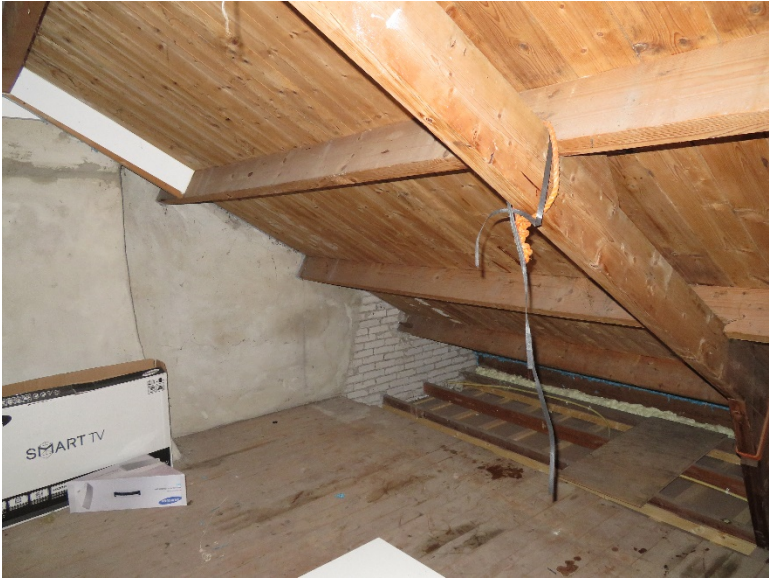
**Figure A35. Attic in renovated building showing evidence of air sealing, but insulation is all exterior, above the roof-line**

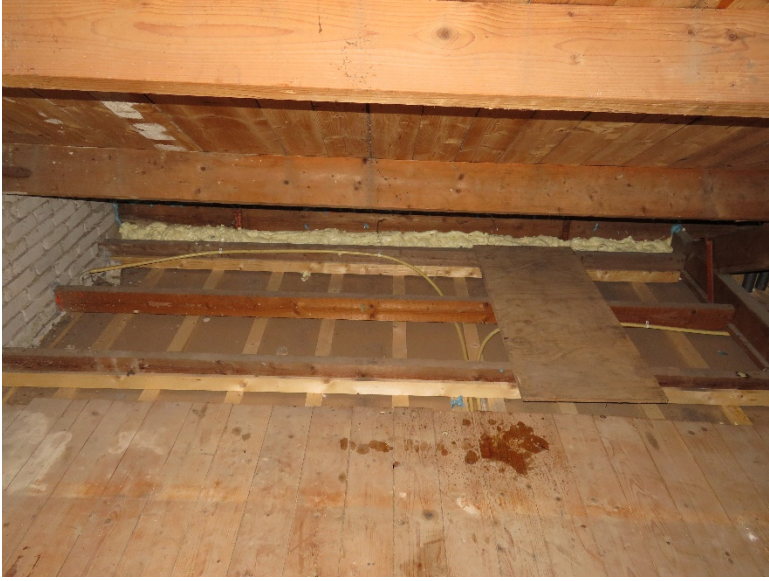
**Figure A36: Attic in renovated building showing evidence of air sealing, but the insulation is all exterior, above the roof-line**
