# **Optimized Strategy for Scaling Up Deep Energy Retrofit**

Final Report

**The New York State  
Energy Research and Development Authority**  
Albany, NY

**Taitem Engineering, PC**  
Ithaca, NY  
Beth Mielbrecht

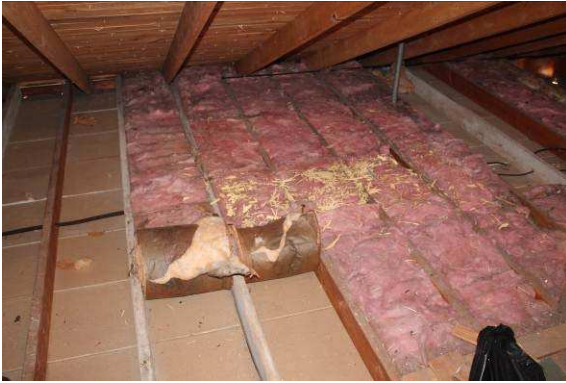
Figure 6: West Hill - Attic insulation removal in progress

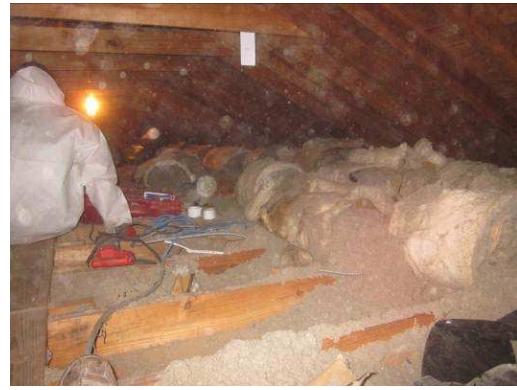
Figure 9: Hawthorne - Attic cleanout in progress

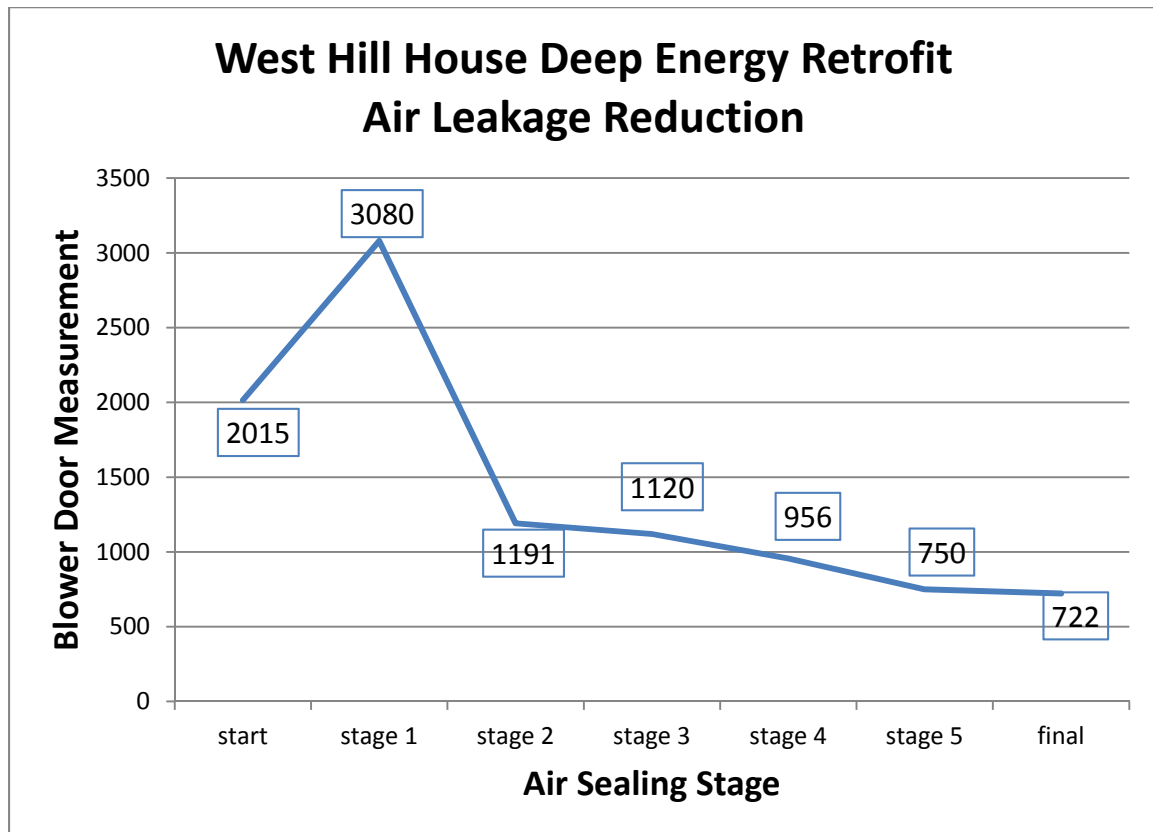
Table 10: West Hill Blower Door Measurements

Air Sealing Stage	CFM50	Work completed
Start	2015	
Stage 1	3080	<ul style="list-style-type: none"> <li>vinyl siding &amp; old foam sheathing removed</li> <li>walls dense packed</li> <li>attic fiberglass removed</li> </ul>
Stage 2	1191	<ul style="list-style-type: none"> <li>attic airsealed</li> <li>band joists spray foamed</li> </ul>
Stage 3	1120	<ul style="list-style-type: none"> <li>wall foam installed</li> </ul>
Stage 4	956	<ul style="list-style-type: none"> <li>sealed fan ducts and exterior top plates</li> </ul>
Stage 5	750	<ul style="list-style-type: none"> <li>Lock top damper, window flashing</li> </ul>
Final	722	<ul style="list-style-type: none"> <li>Final round of blower door guided air sealing, mostly basement sill and band joist</li> </ul>

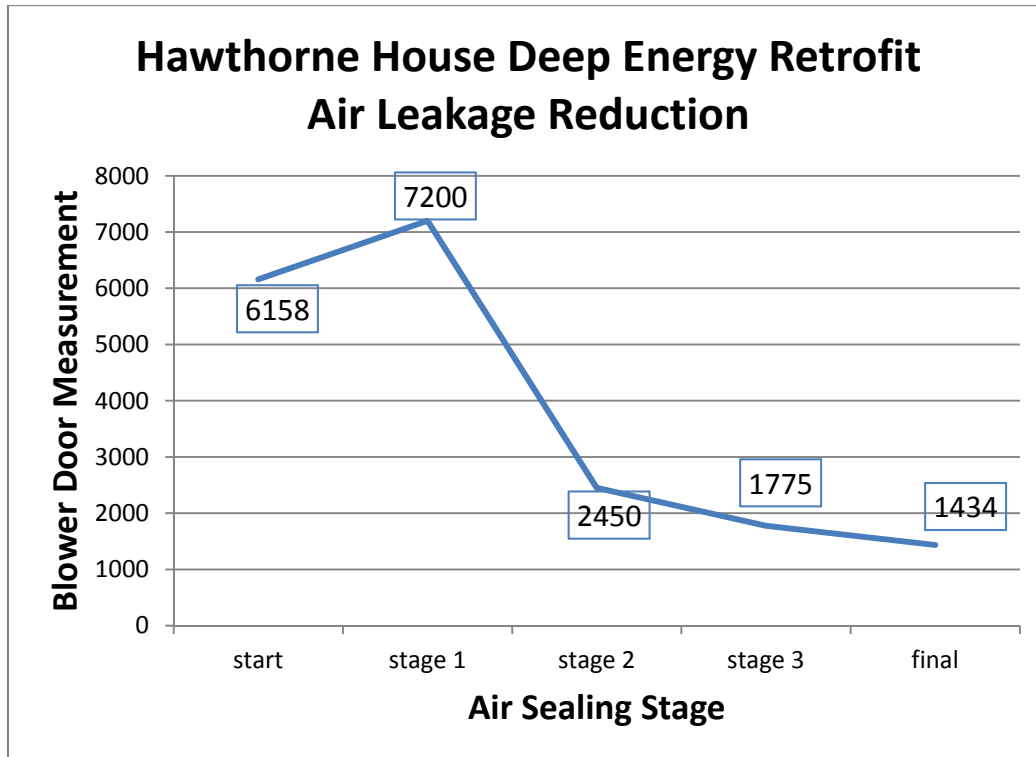
Table 11: Hawthorne Blower Door Measurements

Air Sealing Stage	CFM50	Work completed
Start	6158	
Stage 1	7200	<ul style="list-style-type: none"> <li>Attic insulation removed</li> <li>Siding removed</li> </ul>
Stage 2	2450	<ul style="list-style-type: none"> <li>Windows and back door replaced</li> <li>Above grade walls dense packed and foam board attached</li> <li>Crawlspace vents sealed</li> <li>Crawlspace and basement walls insulated</li> <li>Band joist insulated</li> <li>Damaged sheetrock repaired.</li> </ul>
Stage 3	1775	<ul style="list-style-type: none"> <li>Attic air sealing (top plates, etc.)</li> </ul>
Final	1434	<ul style="list-style-type: none"> <li>Blower door/infrared guided air sealing, mainly of window and door openings</li> </ul>

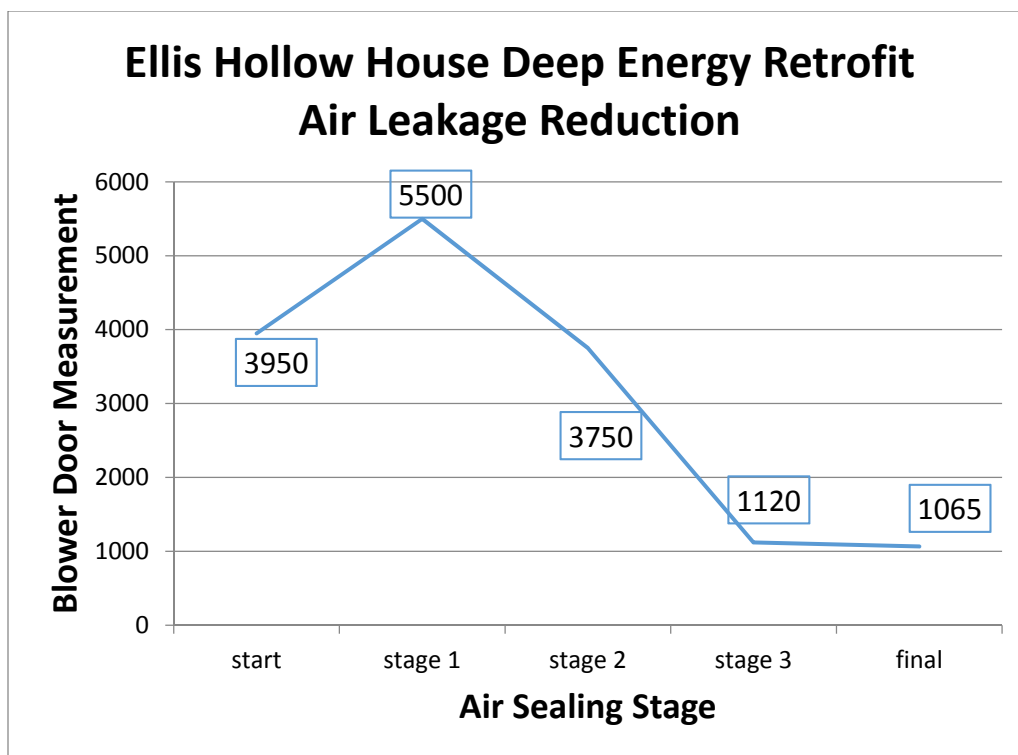
Table 12: Ellis Hollow Blower Door Measurements

Air Sealing Stage	CFM50	Work completed
Start	3950	
Stage 1	5500	<ul style="list-style-type: none"> <li>Attic insulation removed</li> <li>Siding and window trim removed</li> </ul>
Stage 2	3750	<ul style="list-style-type: none"> <li>Window and door replacement in progress</li> <li>Walls dense-packed</li> <li>Attic air-sealed</li> <li>Foam sheathing installed</li> </ul>
Stage 3	1120	<ul style="list-style-type: none"> <li>Window and door installation complete</li> <li>Windows air-sealed</li> <li>Garage insulation and air sealing complete</li> <li>Lock-top dampers installed</li> </ul>
Final	1065	<ul style="list-style-type: none"> <li>Touch-up blower door-guided air sealing</li> </ul>

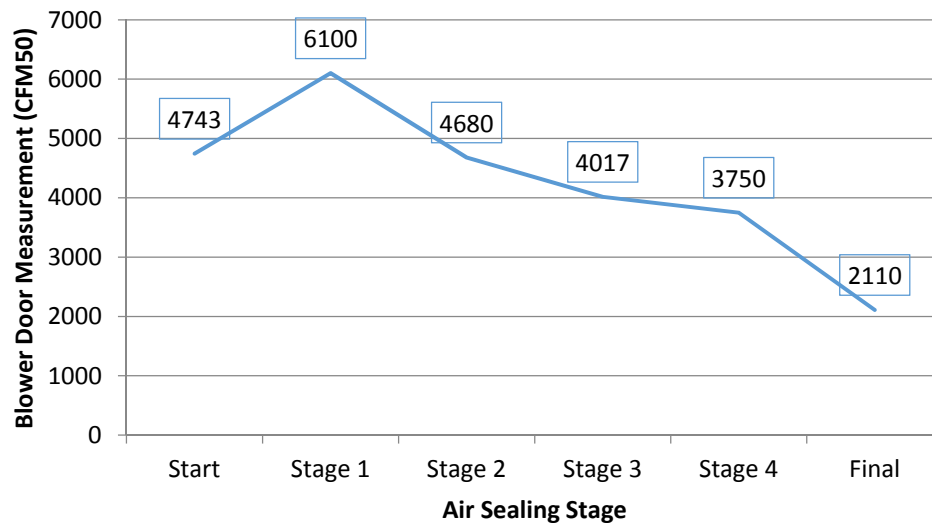
Table 13: Cayuga Heights Blower Door Measurements

Air sealing stage	CFM50	Work completed
Start	4743	
Stage 1	6100	Attic insulation removed; siding removed
Stage 2	4680	Attic and basement rim joist air sealed
Stage 3	4017	Walls dense-packed
Stage 4	3750	Rim joist between first and second floor sealed
Final	2110	Kneewalls insulated and air-sealed; foam sheathing; new windows; blower-door guided air sealing

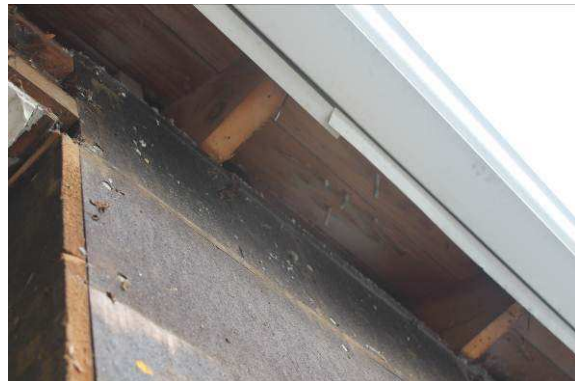
Figure 26: West Hill - Soffit boards were removed so the Thermax can extend up past the top plates. We notched around the rafter tails and sealed the wall/ceiling junction with spray foam from the attic

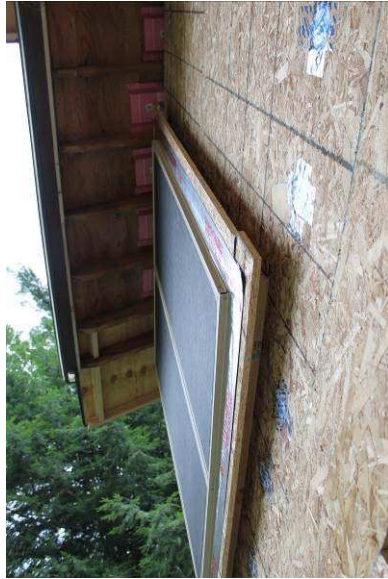
Figure 28: Ellis Hollow - Window buck

- b) At Ellis Hollow, the window buck and flashing techniques developed in the time and motion studies were not utilized. An alternative buck design was developed by the homeowner, incorporating a 2x extension of the rough opening and a 5" wide OSB nailed. The flanged, new construction windows were flashed in the rough opening by the window and siding contractor prior to foam sheathing installation. After the foam sheathing was installed, Weathermate straight flashing and construction tape were installed to protect the OSB and provide a continuous drainage plane.

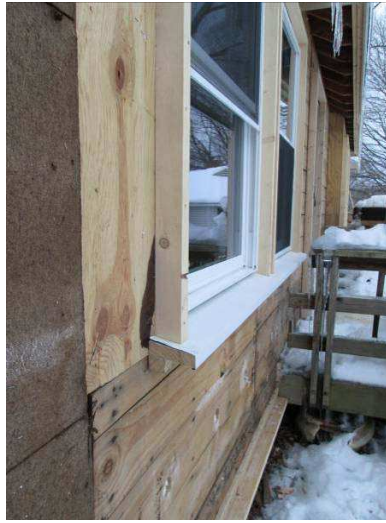
Figure 29: Hawthorne - Window bucks. Note the aluminum flashing covering the sill

- c) The buck and flashing approaches tested in the time and motion studies were designed for new, flanged windows. At Hawthorne and West Hill, the windows were a mix of existing wood/vinyl inserts, which were left in place and new, unflanged vinyl windows, which were installed as inserts to match the style of the existing windows. Bucks, including sill extensions, were built of 2x framing lumber. Aluminum coil stock was bent on a brake to provide an impermeable sill flashing. After the foam sheathing was installed, straight flashing was used to span the joints between the foam and the buck, and between the buck and the window. The flashing was covered with fibercement stops and casings. Straight flashing was also used for the side and head flashings, and a piece of Weathermate construction tape was used to protect the head flashing from low-angle shear per Building Science Corp. recommendations. The straight flashing worked well, although the general contractor complained that it was very hard to remove residue if the flashing extended too far onto the vinyl windows and had to be trimmed back after the fiber cement stops were installed.
