Leaking Shower Diverters: An Overlooked Energy Conservation Measure

By Betsy Jenkins, Senior Energy Engineer, Taitem Engineering

Original Issue November 2011

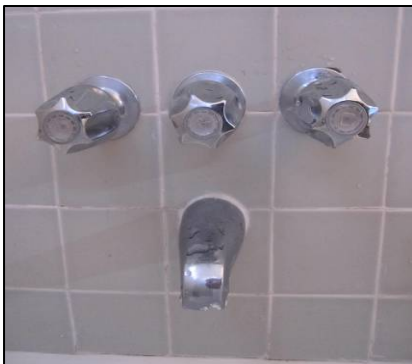
Figure 1: A diverter valve as part of a three-handle shower valve

A diverter is used in combination bath/shower units to direct flow either to the bathtub spout or to the showerhead. Diverter valves like the one shown in Figure 1 use a valve to direct the flow to the showerhead or the tub spout.

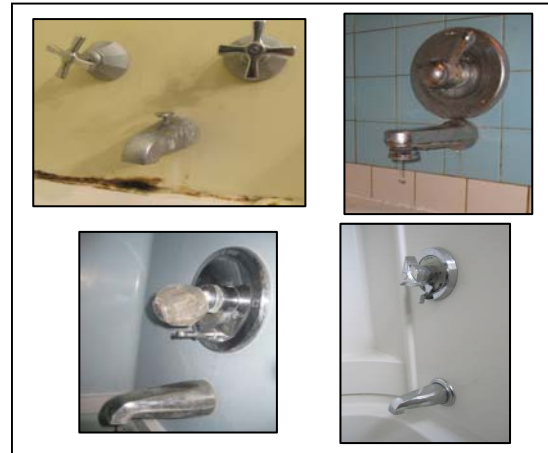
Figure 2: Examples of plate diverters. Clockwise from upper left: a lift on the tub spout diverter with a two-handle valve; a pull-down ring on the tub spout diverter with a single-handle valve; a sliding lever on the valve plate with a single-handle valve; and a button on the valve plate with a single-handle valve.

Plate diverters like those shown in Figure 2 use a plastic or metal plate to stop the water from flowing out of the tub spout. The water gets diverted to the showerhead instead. If the diverter is located on the tub spout, it is called a tub spout diverter.

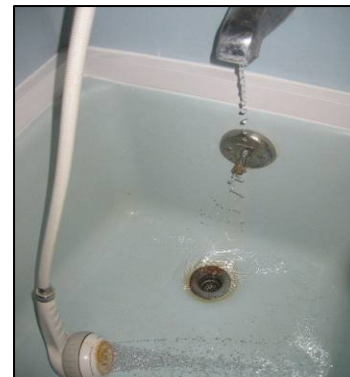
Figure 3: A leaking diverter allows water to flow out both the showerhead and the tub spout simultaneously.

When a diverter valve is working properly, water only flows out of either the tub spout *or* the showerhead. However, diverters very often leak and water flows out of the tub spout even when in shower mode (see Figure 3). This leakage goes directly down the drain without being available to the person taking a shower. Both the water and the energy used to heat the water are wasted.

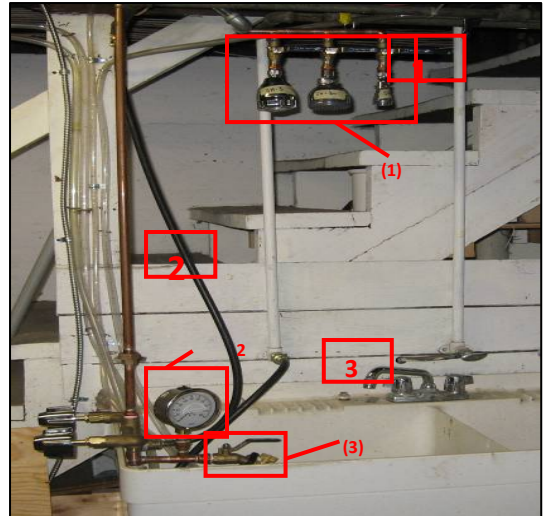
Figure 4: Test rig with (1) multiple showerheads, each with their own shutoff valve; (2) a pressure gauge; and (3) a throttling valve to simulate various tub spout leak sizes

We constructed the test rig shown in Figure 4 to test how the flows through the showerhead and tub spout interact in various scenarios. We focused our testing on tub spout diverters and performed the three tests described below. We used a pressure reducing valve (not shown in Figure 4) at the main water supply for the building to vary the system pressure. We also installed a ball valve in place of the tub spout diverter to simulate various leak flows.

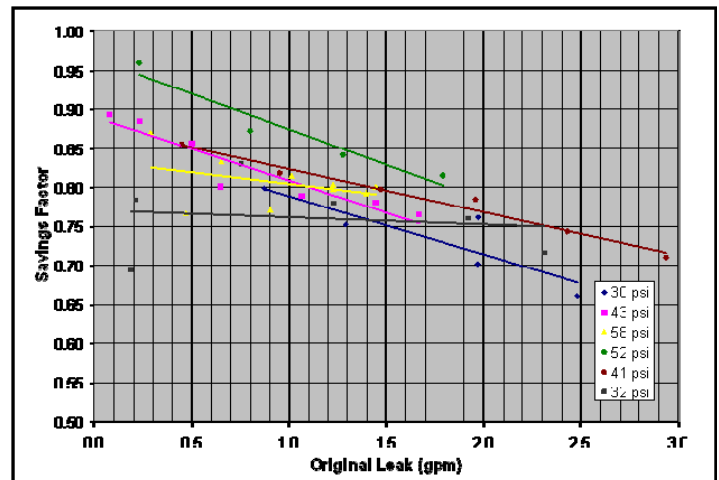
Figure 5: Calculated savings factor for SH-1 at various leaks and system static pressures

system pressure, the savings factor decreased as the size of the original leak got larger. (See Figure 5.) We also found that the savings factor was almost always greater than 0.7, regardless of the showerhead, system pressure, or leak flow.

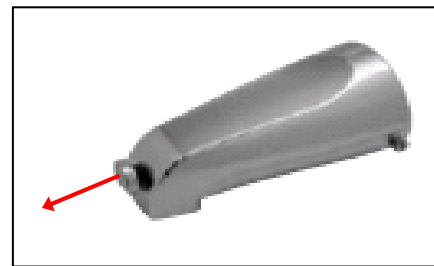
Figure 6: TS-20, the Positive Action Shut-off Mixet tub spout diverter by BrassCraft

Out of all the tub spout diverters we tested, four performed the best: TS-2, 6, 7, and 20 leaked minimally at all system pressures. TS-2, 6, and 7 are standard models; we can identify no design feature that would make them perform better than any of the other spouts we tested. TS-20, however, has a different design: it is the Positive Action Shut-off Mixet diverter by BrassCraft. Like the pull-down ring type diverters, a spring holds the diverter plate in the open position. Instead of pulling up on a lift to engage the diverter, one pulls straight out, in line with the tub spout. (See Figure 6.) When the water is turned on and the lift is pulled, water pressure causes the diverter to stay in the closed position. According to the product literature available from BrassCraft, the internal configuration of the spout was designed to make the seal very effective even at low pressures. Our testing showed that this tub spout diverter was the most effective; none of the other diverters performed so consistently well across all pressures.

We recommend using the BrassCraft Positive Action Shut-off Mixet tub spout diverter, or a diverter with similar functionality, where possible. This spout is currently available from several sellers on the internet, and its price (approximately \$20) is in line with the other spouts we tested. It is available in both threaded and slip-on configurations, in two lengths, and with a variety of finishes.
